Intel[®] Mobile Pentium[®] II Processor Specification Update

Release Date: March 2001

Order Number: 243887-030

The Mobile Pentium[®] II processor may contain design defects or errors known as errata which may cause the product to deviate from published specifications. Current characterized errata are documented in this Specification Update.

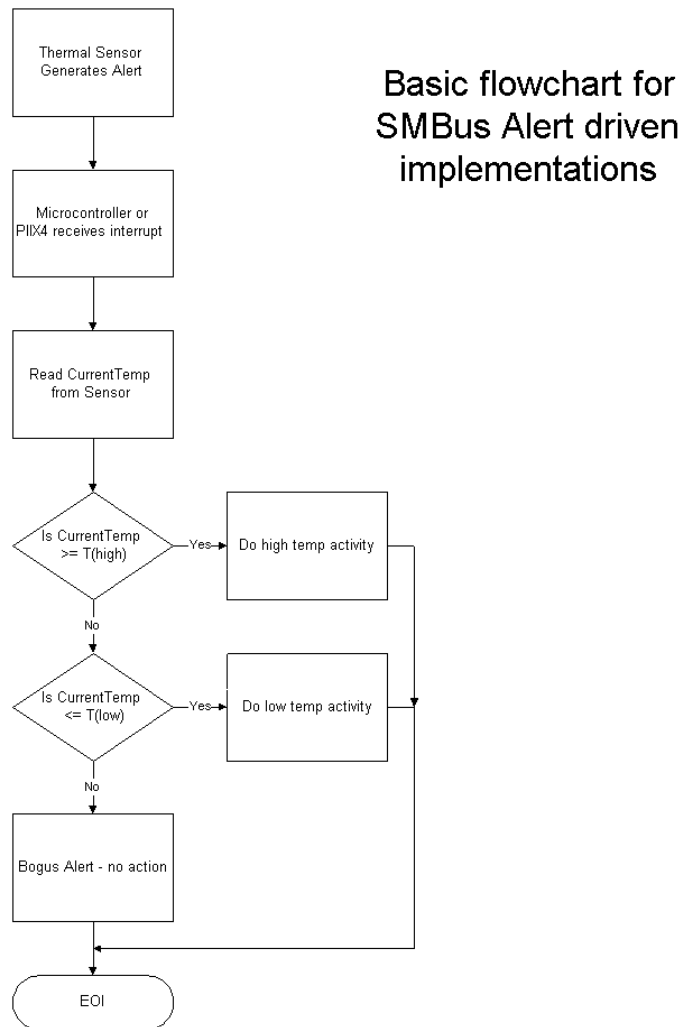
Figure 2. Workaround Flowchart: SMBALERT#-Driven System

Under the conditions described below, the thermal sensor incorrectly generates the SMBALERT# interrupt. All of the following conditions must be met to trigger a false interrupt:

1. Before servicing an interrupt from the thermal sensor, read and compare the processor thermal reading with the threshold limits (T_{HIGH} or T_{LOW}). Figures 2 and 3 provide basic flowcharts for the implementation of this workaround in an interrupt driven system.
2. If the firmware implemented polls the Status Register only, then before taking any action, re-read the temperature register and do a comparison with the alarm threshold limits (T_{HIGH} or T_{LOW}) to determine if the value is actually still within the temperature window.

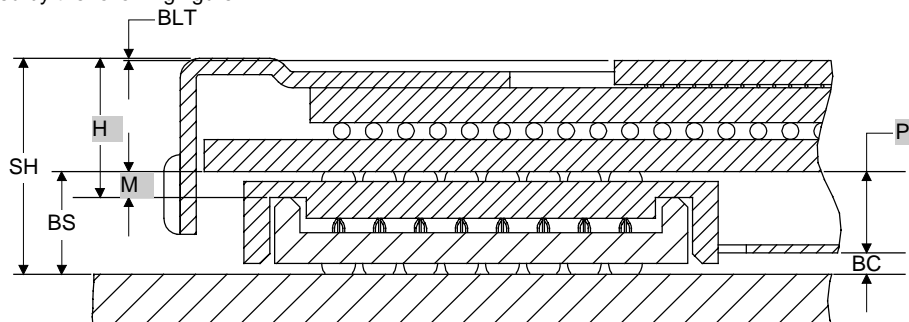
Figure 5.6. Cross Sectional View with Vertical Dimensions

B1. Mislabeled Vertical Dimension Parameters

Figure 5.6 in the *Mobile Pentium® II Processor at 233 MHz, 266 MHz, and 300 MHz* datasheet should be replaced by the following figure:
